NASA CR-54719

SNAP-8 MATERIALS REPORT FOR JANUARY-JUNE 1965

BY H. DEROW AND B. E. FARWELL

REPORT NO. 3038 (SEMIANNUAL) / JULY 1965 / COPY NO. **13**

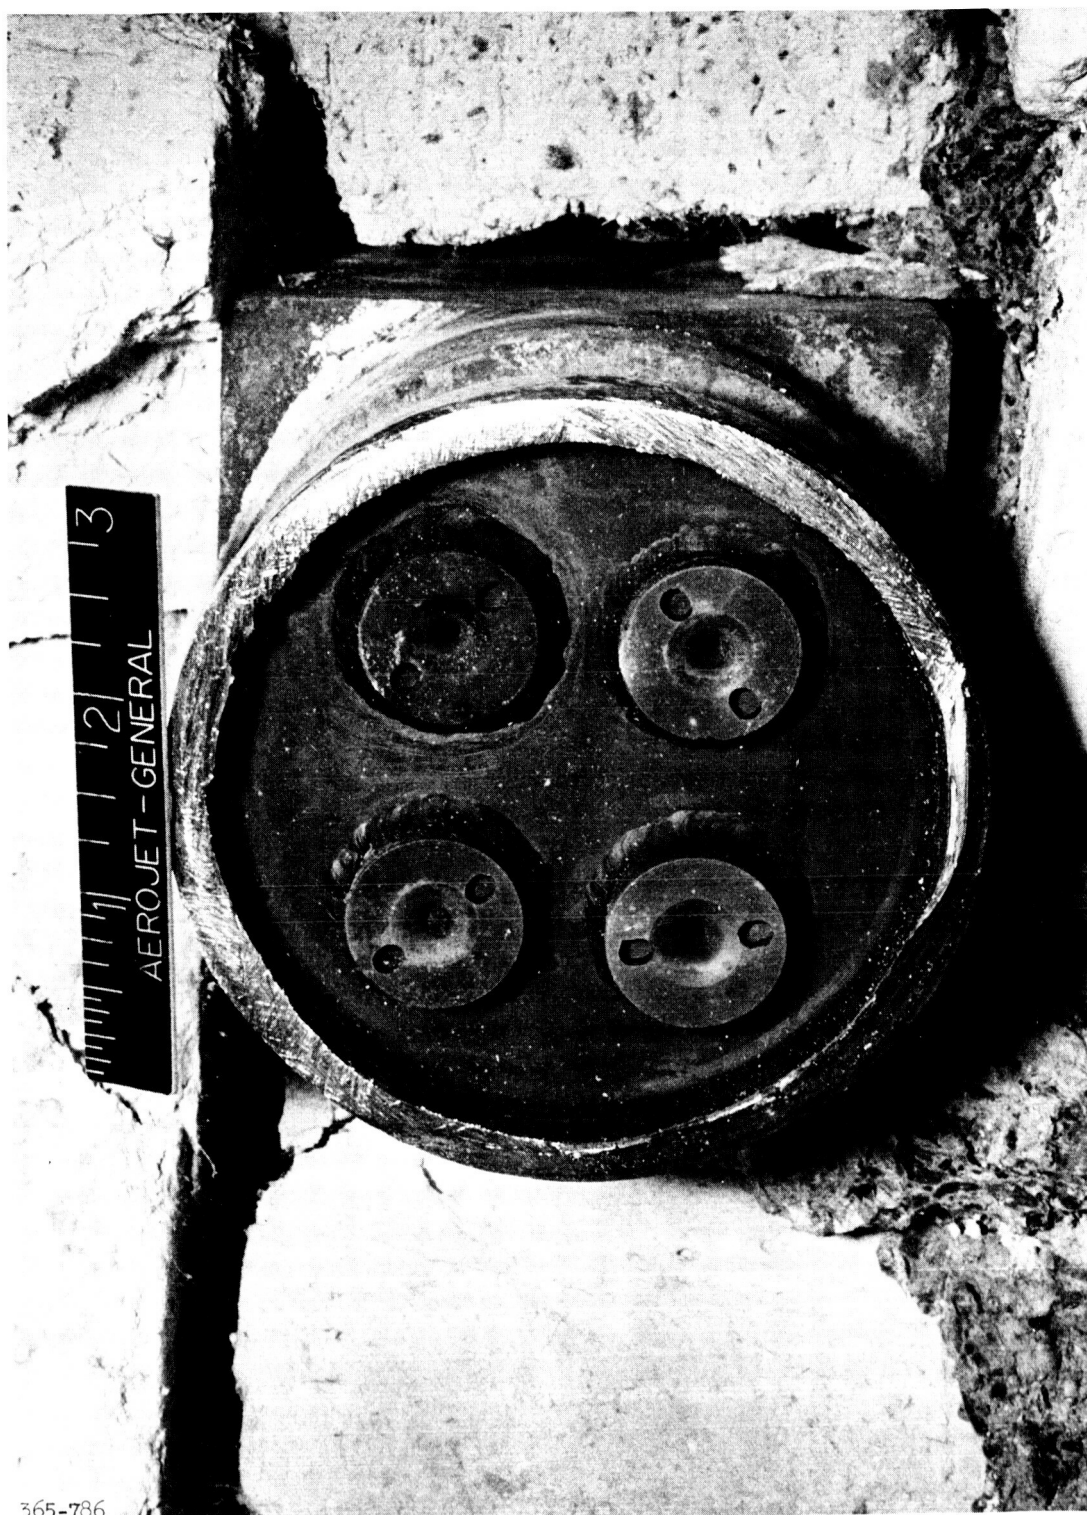
Figure 2

After the March test period, the boiler-inlet manifold was removed. A particle was found lodged in the upper-left tube-inlet-restrictor orifice (see Figure 2). Evaluation indicated that the particle was of mild steel and probably was a machining chip (see Ref. 5, p. IV-3). Potential loop sources for this chip are the turbine-simulator lines and some mild-steel parts of the boiler.

SNAP-8 -1 Boiler, Mercury-Inlet Manifold Showing Blocked Inlet Restrictor (Upper Left)

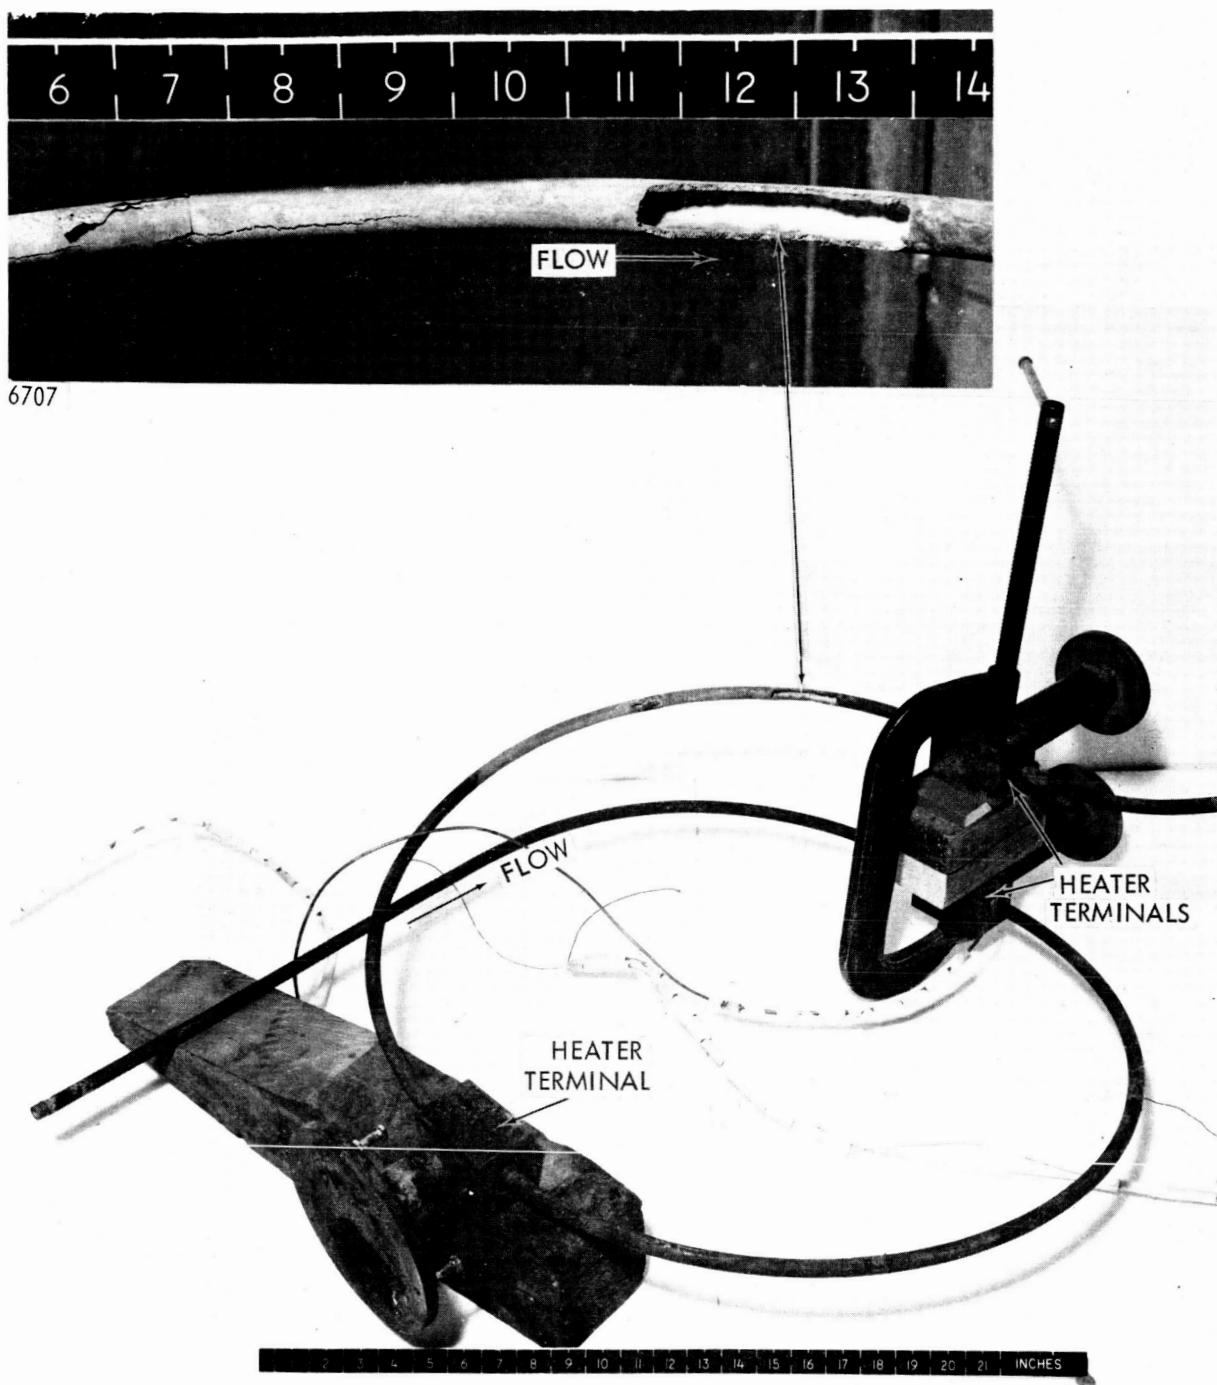
Corrosion Loop 3 (CL-3) was removed from its test cells and disassembled after a section of 316 SS tubing failed in the NaK heater, causing a shutdown. The failure resulted from intergranular cracking associated with a second phase that precipitated heavily at the grain boundaries, especially in the failure area. Selective etching indicated the precipitate may be sigma phase.

NaK-Heater Tube Showing Area of Failure, Corrosion Loop 3 (CL-3)

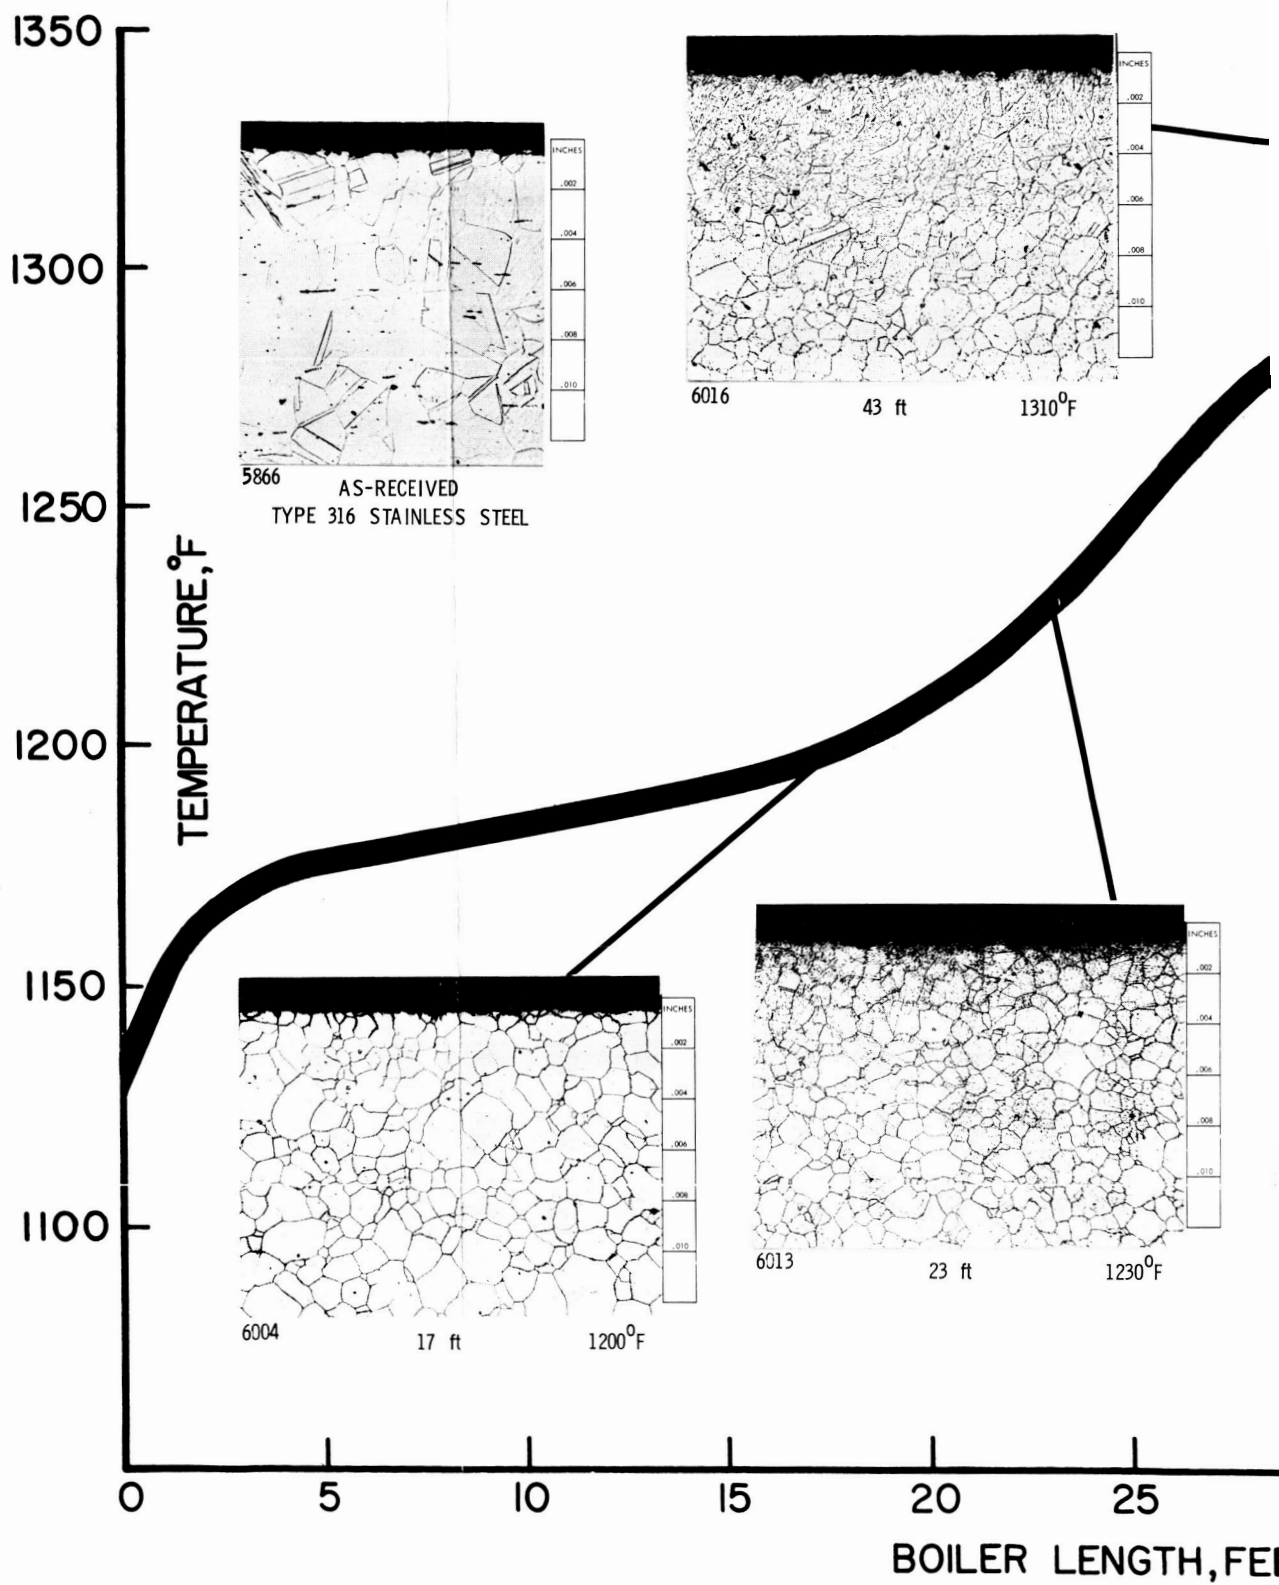
Figure 16

The boiler performance constantly improved during the first 2000 of a total 4400 hours of operating time. The 316 SS outer shell of the mercury boiler showed no evidence of corrosion. There was some carburization of the 316 SS in the hottest section of the boiler (1310°F). The NaK side of the 9Cr-1Mo mercury-containment tubing exhibited decarburization, primarily at and near the NaK-inlet end. The decarburization depth decreased gradually along the boiler toward the NaK outlet, where the temperature had decreased to approximately 1270°F. No decarburization was observed in tube sections where the NaK temperature was below 1270°F. Some exterior cracking of the 9Cr-1Mo steel tubing was also observed, most of it in the area of highest heat transfer. Tube cracking was also observed on the mercury side (interior). Pitting was found on the 9Cr-1Mo steel boiler-inlet plug (5 ft long) in the area 7 to 21 in. from the boiler inlet. The inner surface of the 9Cr-1Mo steel tubing in the plug area was lightly pitted. The NaK-temperature profile of the boiler indicates practically no heat transfer in the plug region after the preheating of the liquid mercury in the first 2 ft of the boiler. Examination of the interior of the 9Cr-1Mo steel boiler tubing following the plug region indicated heavy pitting and surface cracking in some sections, especially where the heat transfer from the NaK to the mercury was the greatest. Corrosion-product deposition was also found in that area.

Microstructure of 316 SS Outer Sh

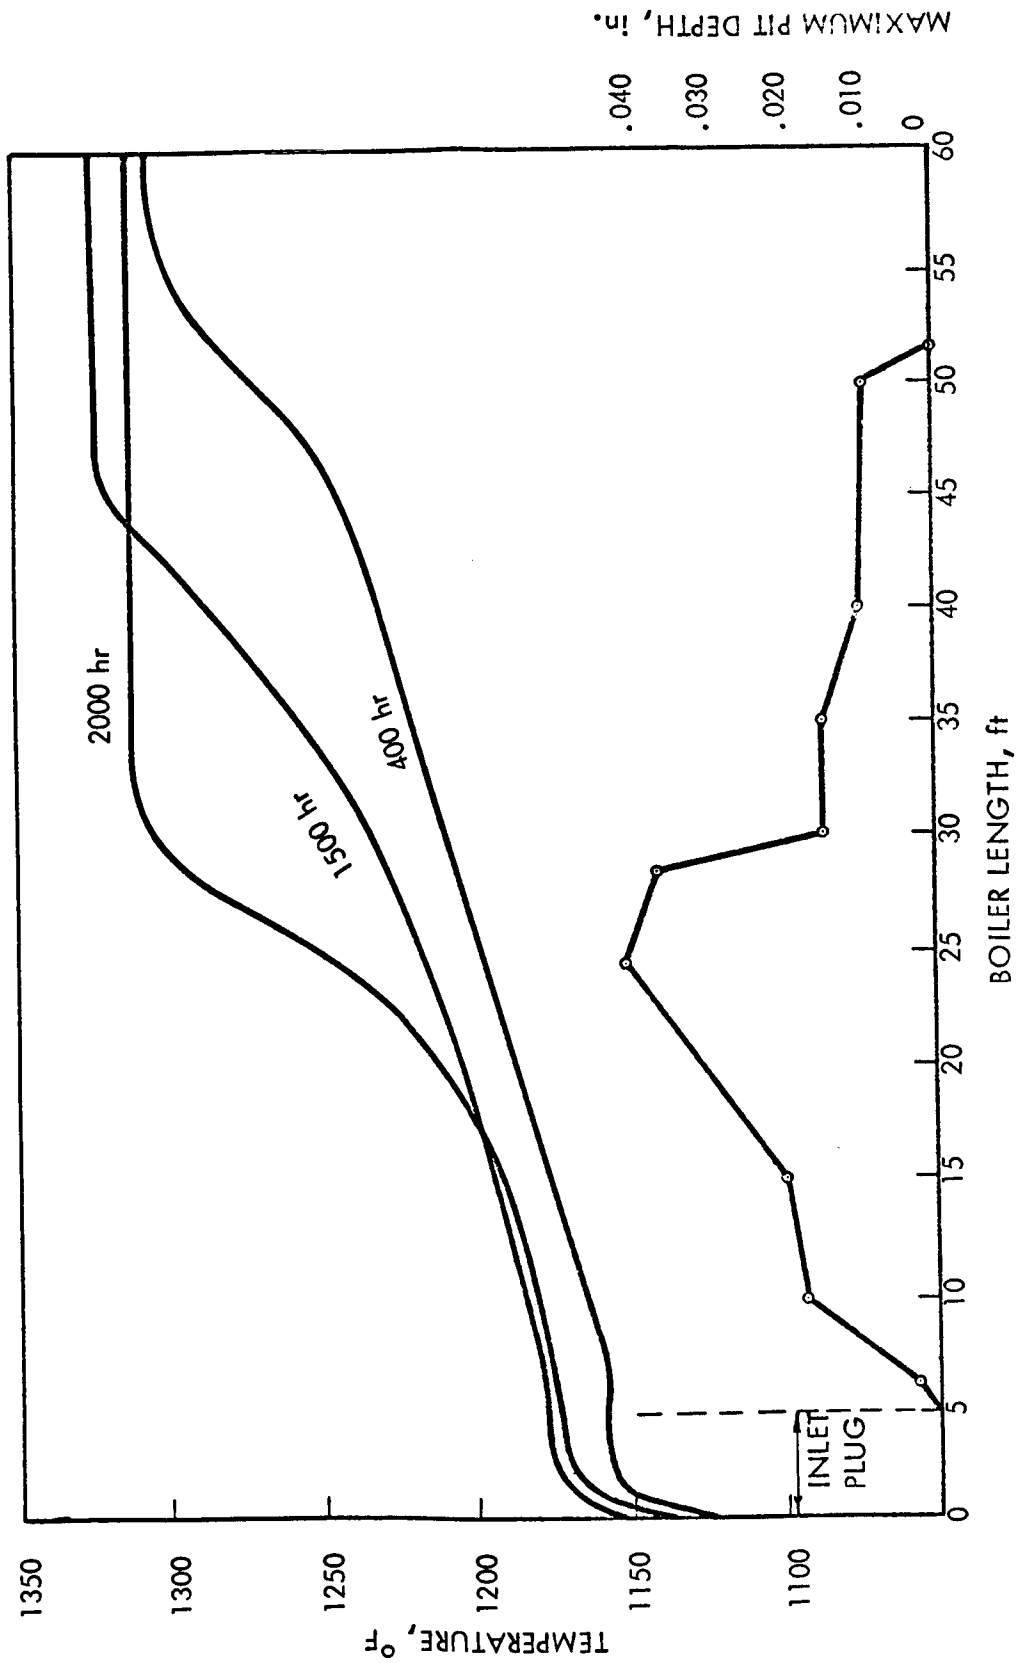
Figure 20

Most of the corrosion-product deposition in the mercury loop was found 25 to 30 ft from the boiler inlet, where the pitting depth increases sharply. The corrosion products are deposited from supersaturated liquid mercury in the liquid vapor stream as the vapor quality approaches 100%.

Pitting Depths in 9Cr-1Mo Steel Tubing, CL-3 Boiler

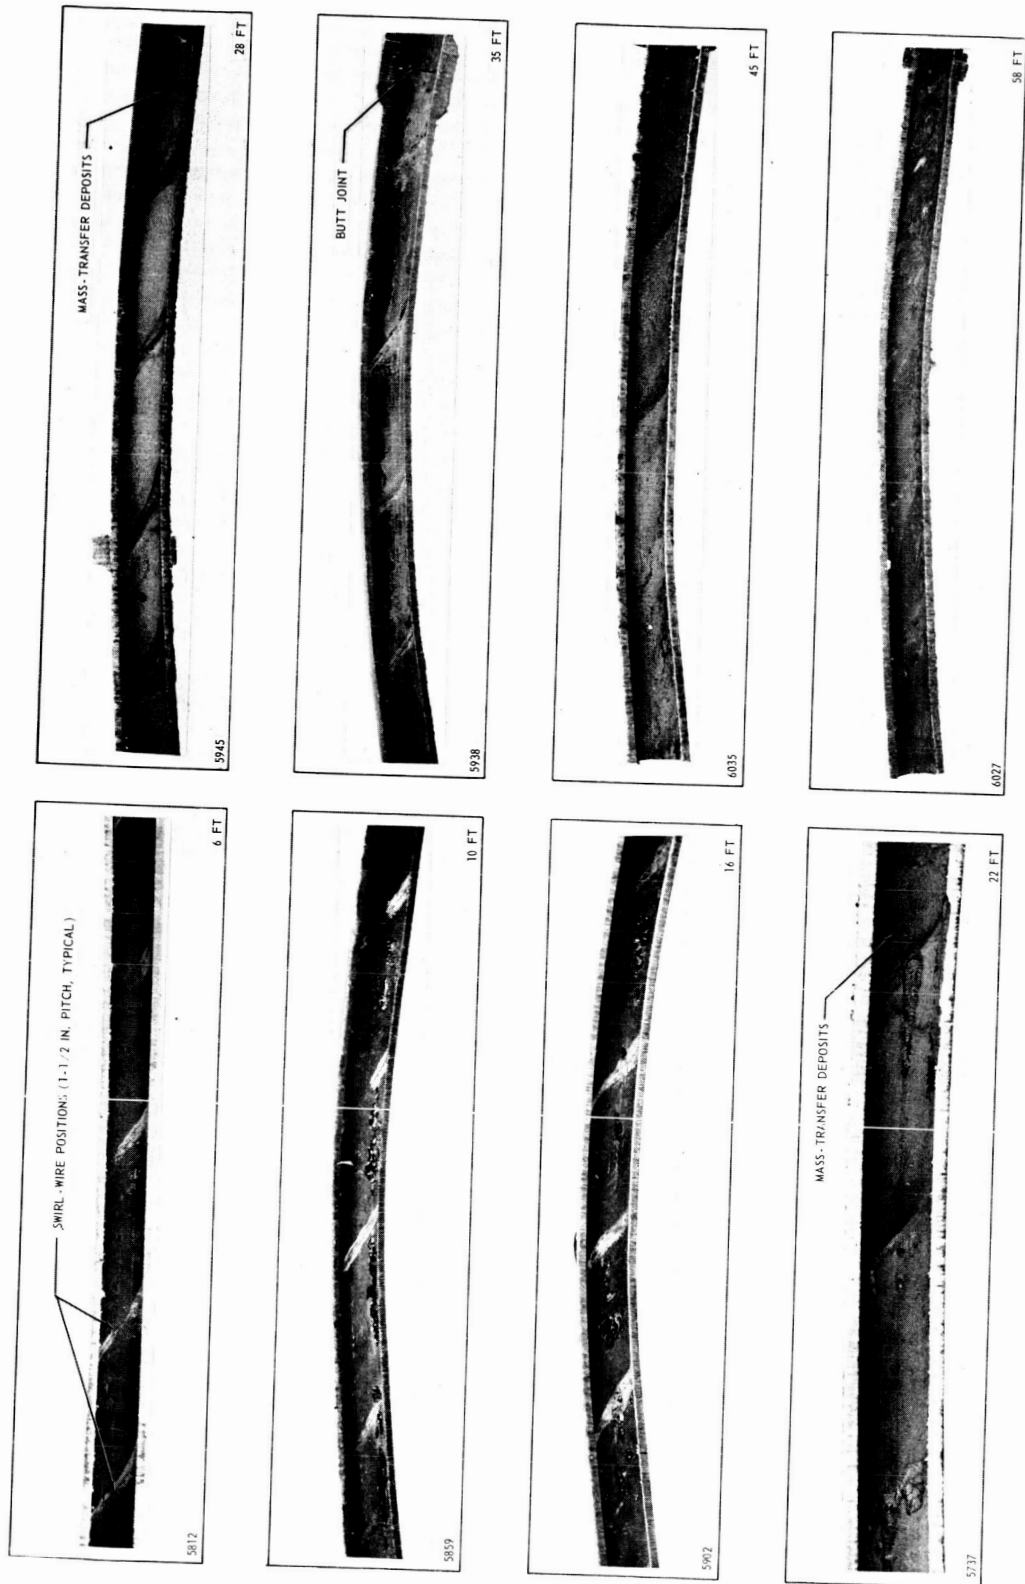
Figure 21

The change in the NaK-temperature profile with operating time indicates that the mercury-flow pattern was changing constantly up to 2000 hours of operation. This would account for the pitting and corrosion-product deposition observed in the region 30 to 50 ft from the mercury inlet.

Views of Pitting in 9Cr-1Mo Steel Tubing, CL-3 Boiler
